Blocked oilways in Sq4s that have been stored or have had infrequent oil changes.

The following tell how and why to remove the sludge that blocks the crankshaft oilways in Sq4s. They were posted as e-mails but the wealth of experience and technical information is so great that I saved them here.

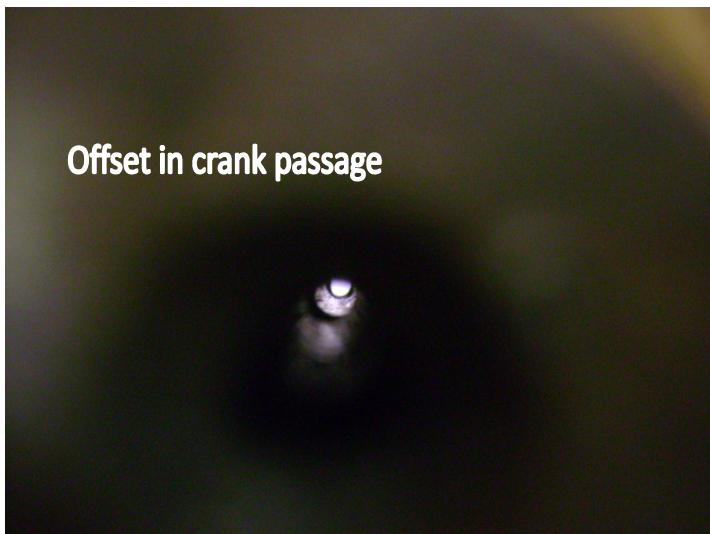
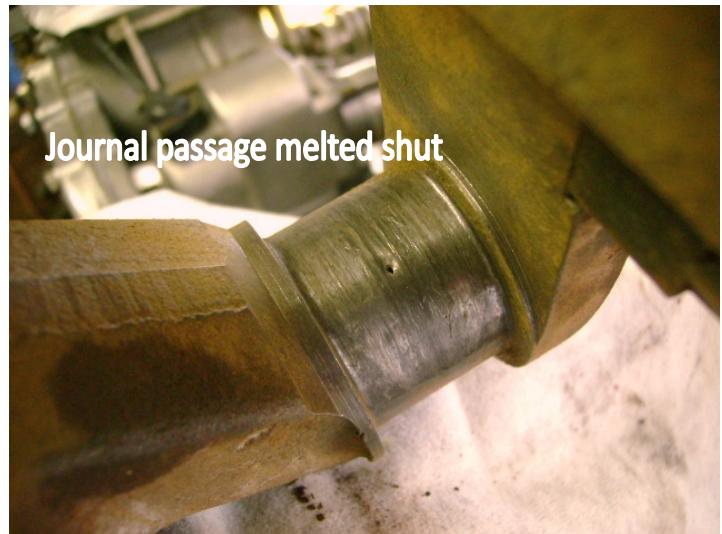
Following the recent oil passage and sludge trap comments, I opened the sludge traps on one of my "spare" front crankshafts and found the following. Predictably the sludge had impacted in the gallery in front of the two countersink screws, so hard it needed drilling out. Then I found that the gallery through the centre of the crankshaft is drilled to 5/32" (3.9mm). The hole appears to be original with an offset in the centre of about 1mm where the holes don't quite line up. It does not look to have been tampered with. The feed hole to the number one big end

bearing is 3/32" (2.4mm) but the feed hole to number four bigend is melted shut. The centre of the main gallery at the offset junction of the holes was blocked solid and needed hammering out with a thin rod. The supply hole in the main journal at number one is 7/32" (5.5mm). The crank has a "Y" stamped on one bigend casting if that means anything to anybody. Incidentally, the material that was blocking the gallery appears to be grit or sand based plus oil, with a few very small metal particles. total amount would probable fill two plastic valve caps. When the rod let go, it left some healthy dents in the crank; about 1.5mm deep.

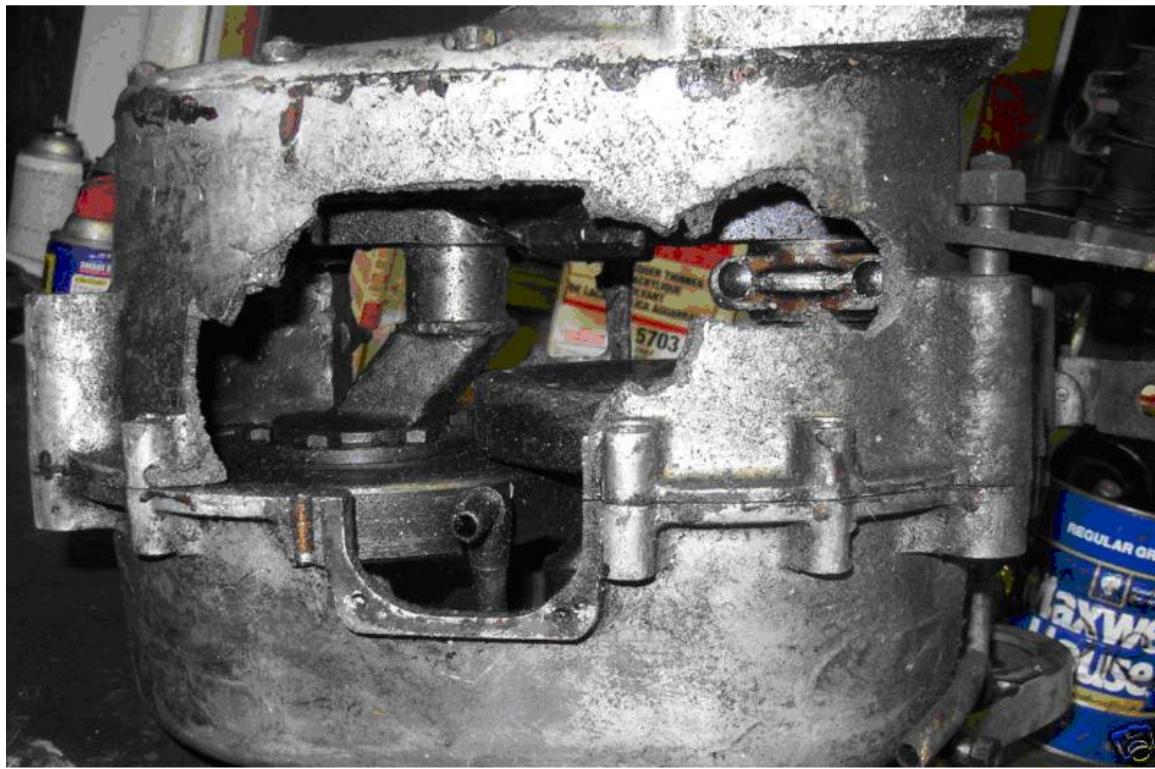
Here's an ebay picture of a Sq4 crankcase destroyed by a thrown rod.
